SAFE AND SOUND HOUSE INSPECTIONS LTD

STANDARD HOUSE INSPECTION REPORT

PROPERTY ADDRESS:
Sample Property

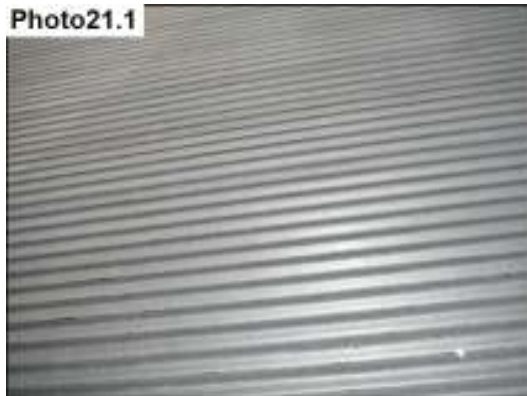
Roof area needs washing down

The roof is corrugated iron. The roof area needs to be washed down to remove the dust and debris. This is recommended at least once every 12 month, this helps to keep this product in good order and is required for the guarantees for this product.

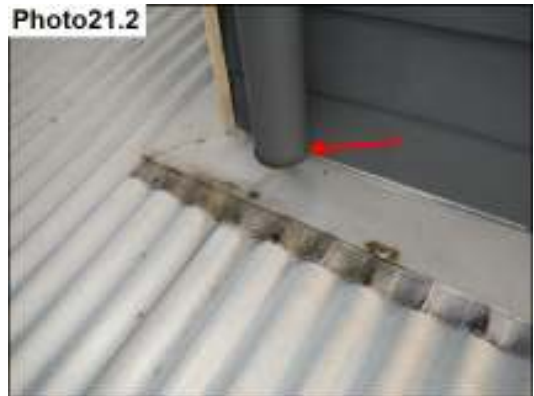
Recommend fitting spreader pipes to the bottoms of the down pipe.

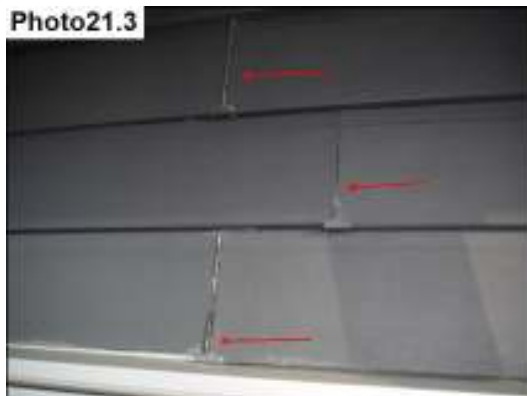
Back soakers fitted to the weather boards.

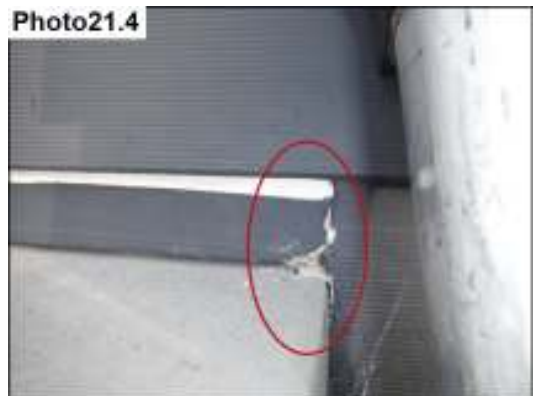
Cracking note to the weather board around some of the flashings.

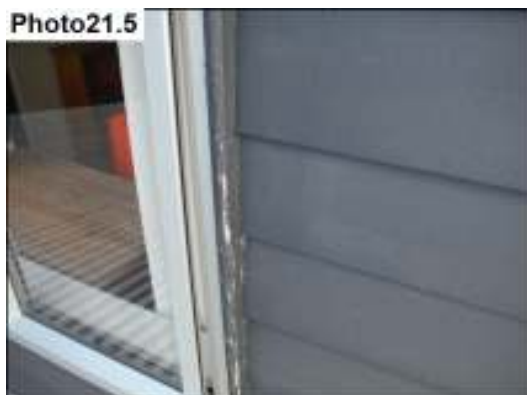
House will need repainting in the near future.

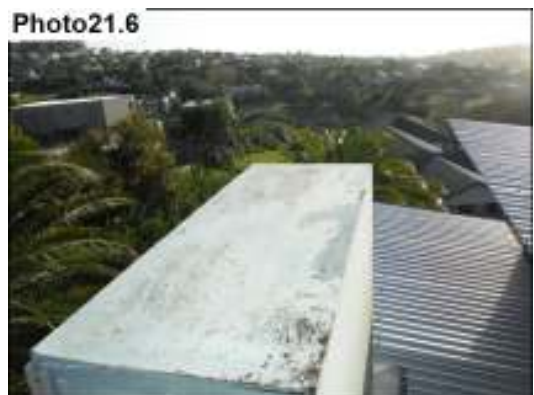
False chimney wasn't painted last time the house was. This needs attention.

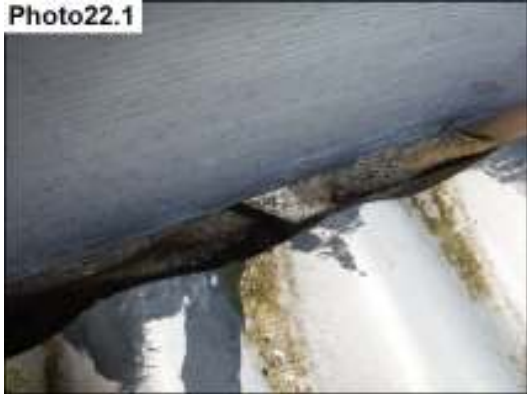
Photo22.1

Internal gutter along the front of the house need the debris cleaning out.

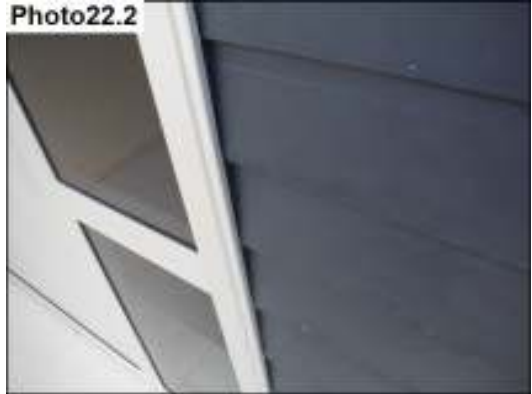
Photo22.2

Scabber needs installing to the front door.

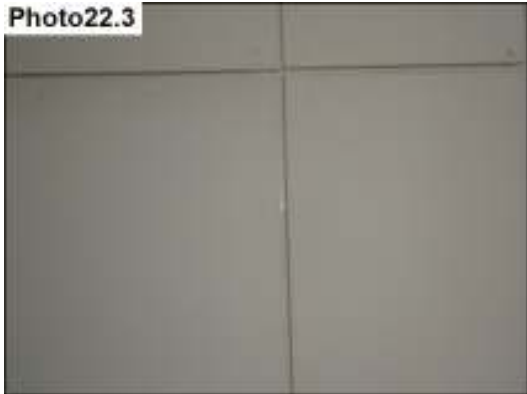
Photo22.3

Flat sheet cladding needs painting in the future.

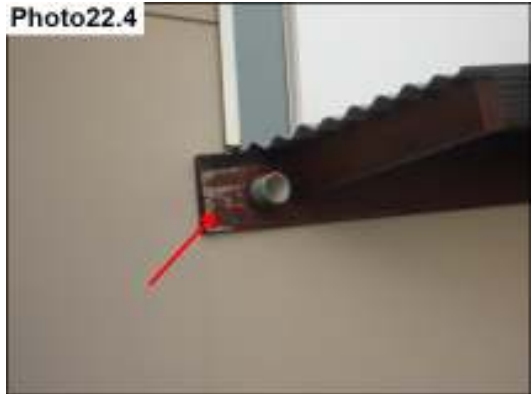
Photo22.4

Fascia boards need painting.

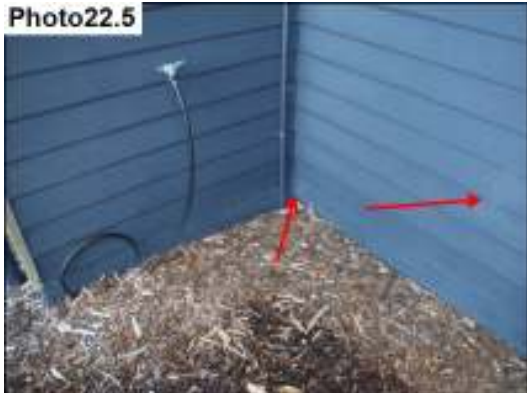
Photo22.5

Paint is see thru in places

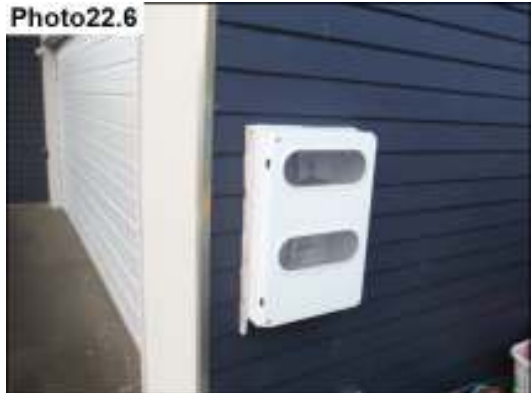
Photo22.6

Meter box needs the scabber finishing off and needs painting.

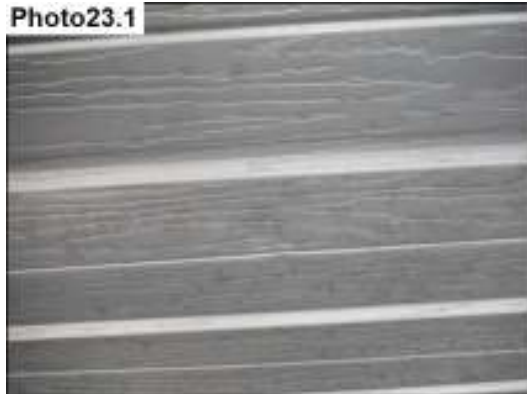
Dents noted in the garage door.

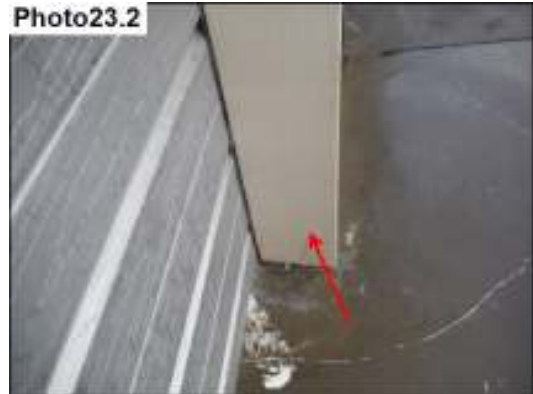
Garage door surround needs sealing and painting.

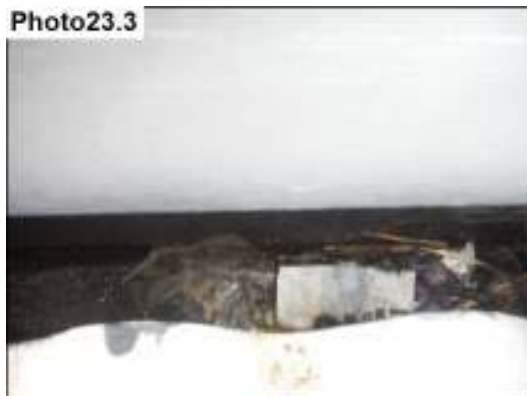
Debris in the internal gutter noted.

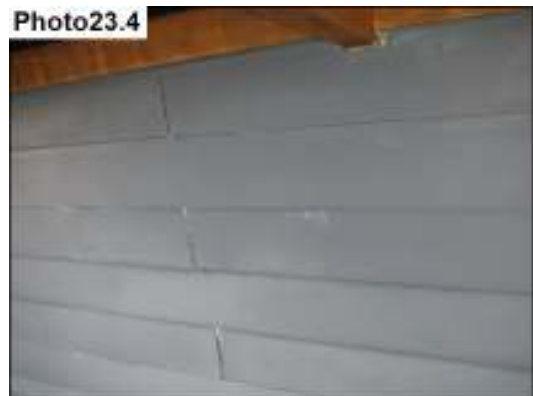
House will need repainting in the near future.

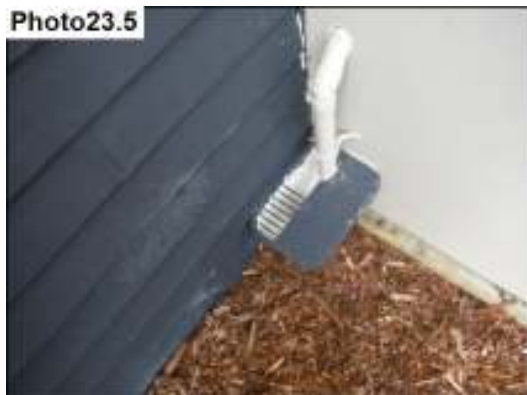
No smell or leaks noted to the gully traps.

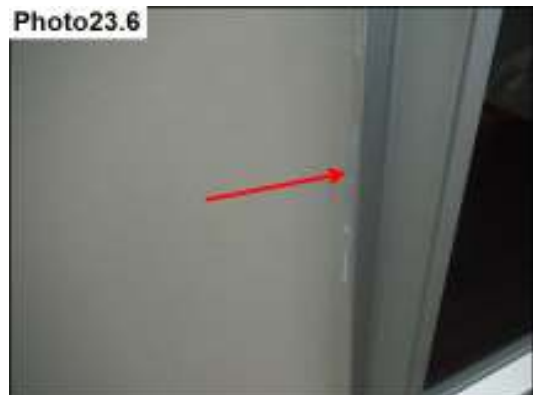
Window need to be resealed to the cladding when the house is painted.

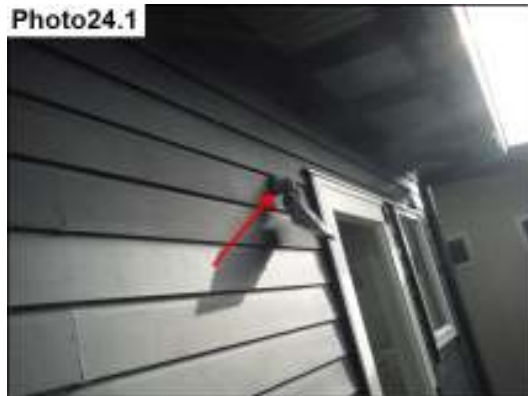
Outside light fitting is broken

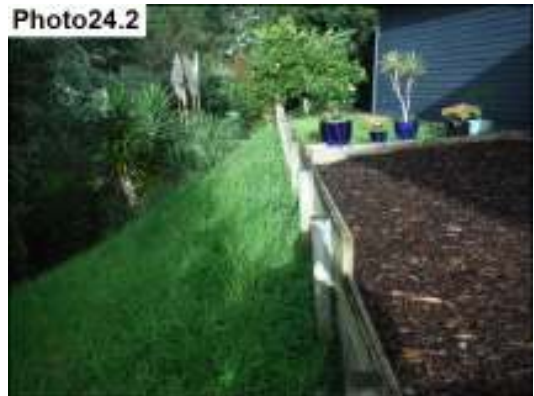
Movement noted to the rear timber retaining wall.

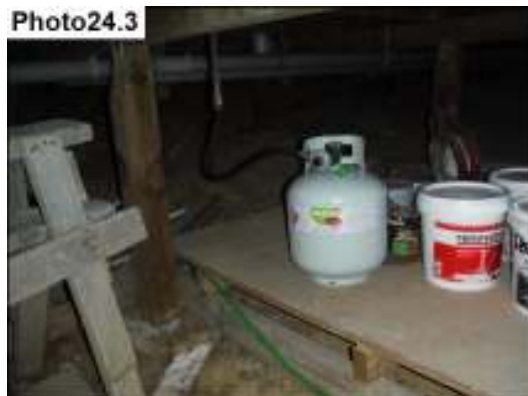
Gas bottle for the gas hob is under the house.

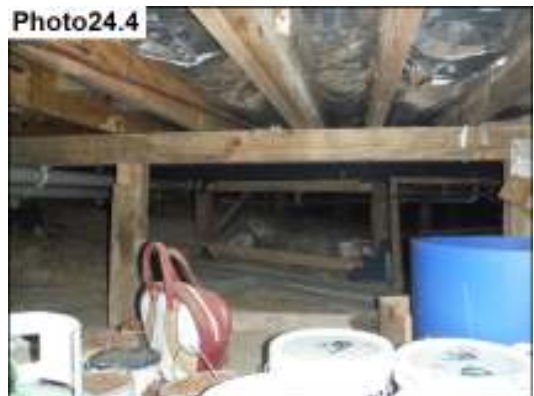
Silver foil is under the flooring.
Drainage is well supported

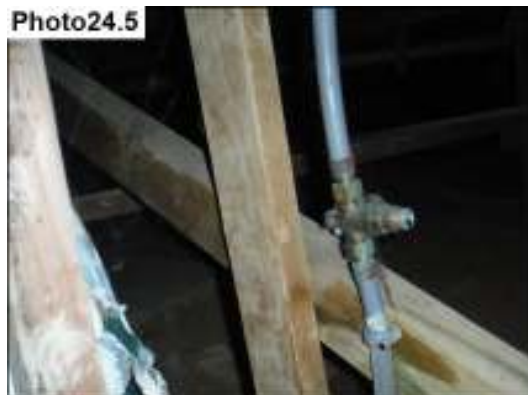
Leak in the pipe fitting next to the hot water tank.

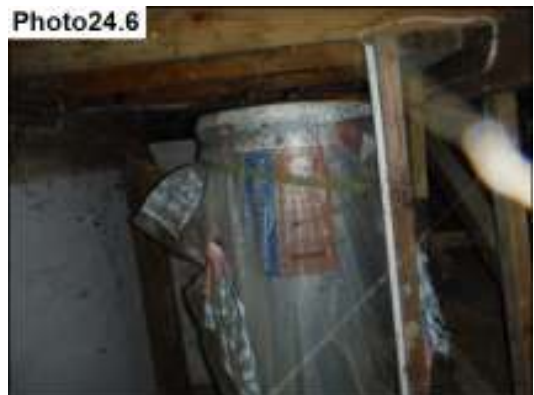
250 litre mains pressure hot water tank is under the house.
Date stamped 02/2002

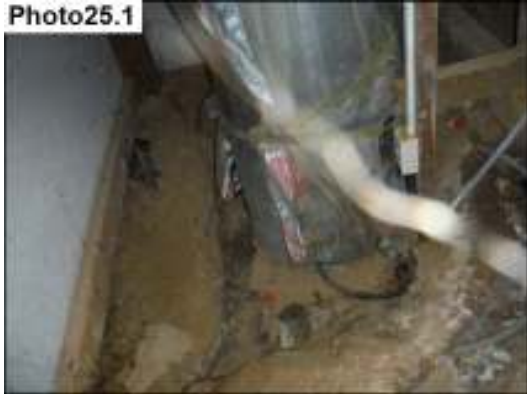
Photo25.1

Water around the base of the hot water tank. This needs to be raised off the ground.

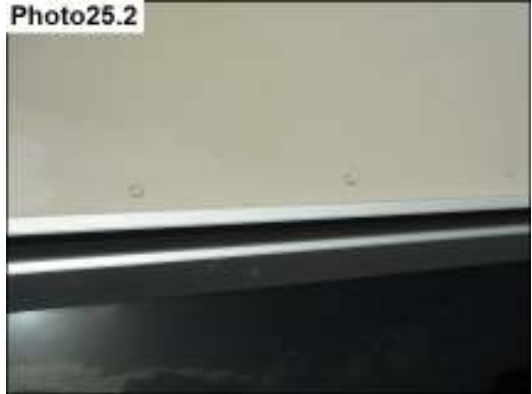
Photo25.2

Popped nails noted to the flat sheet cladding.

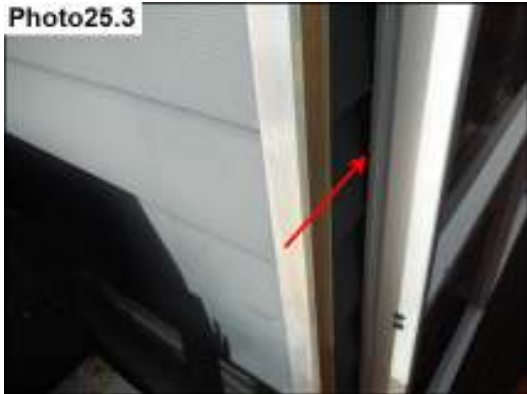
Photo25.3

Ranch slider need to have scribes fitted.

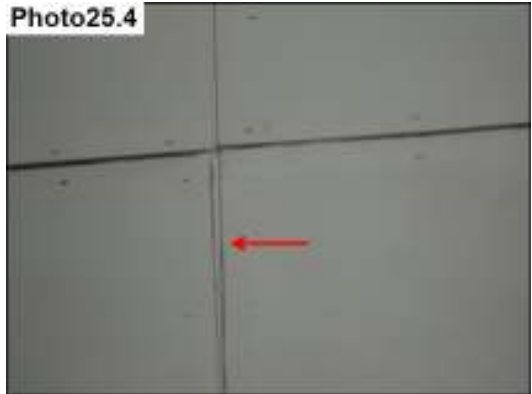
Photo25.4

Cracking noted to the joints on the flat sheet cladding.

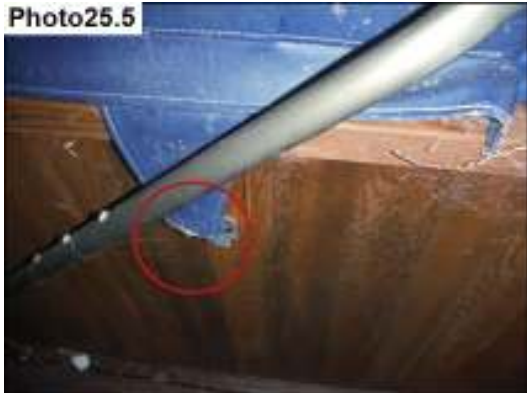
Photo25.5

Broken and missing tabs noted to the SPA pool.

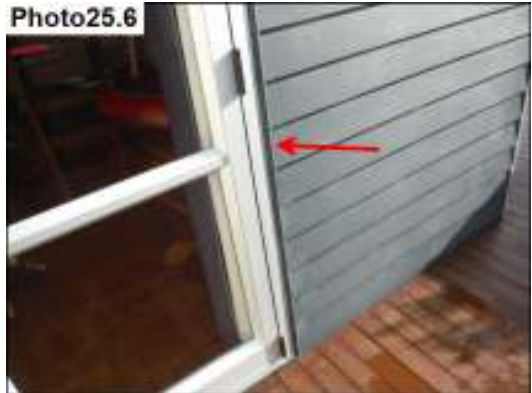
Photo25.6

Scriber fitted to the other doors.

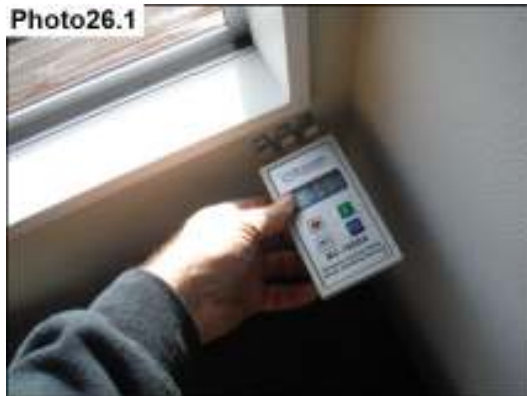
Moisture reading to the dining area.
9.0%

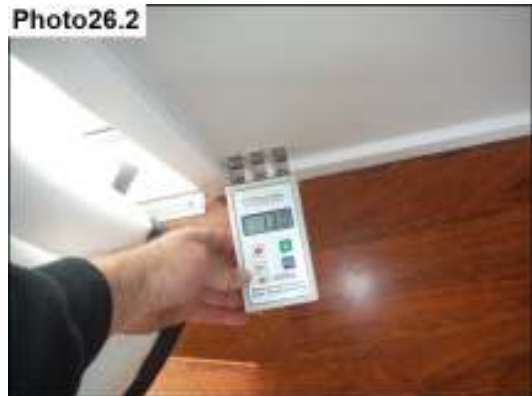
Moisture reading where scribe not
installed.
13.0%

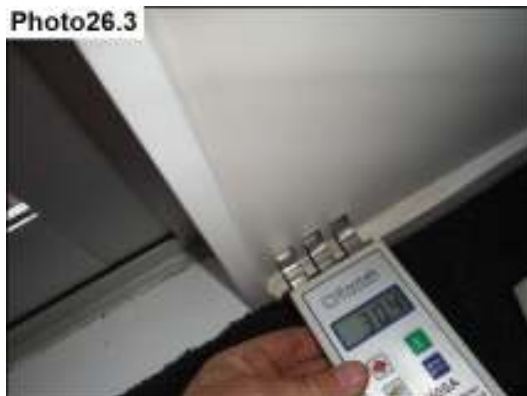
AREA	Moisture	Water/Mold marks	Action	Comments
Ceiling	NO	NO		
Walls	YES	NO	Needs attention	Around the ranch slider from the second lounge.
Floor	NO	NO		
Around shower	NO	NO		
Around bath	NO	NO		
Next to toilet	NO	NO		
Laundry Area	NO	NO		
*NO /YES - high moisture readings were recorded during the inspection				
If a moisture scan reveals elevated or high moisture readings then further investigation might be needed to assess the framing condition. Consult with your Inspector. Obtain relevant information from the Vendor about past and present leaks if possible. Same applies to Marks - obtain relevant information from Vendor. Only water related marks will be reported in this section. As Mould could only be identified by a Lab, then "Mould" is used to describe possible Mould presence in black stains.				
PLEASE REFER TO PHOTO SECTION FOR MORE DETAILS

Moisture reading to the ranch slider
from the second lounge area.
30.4%

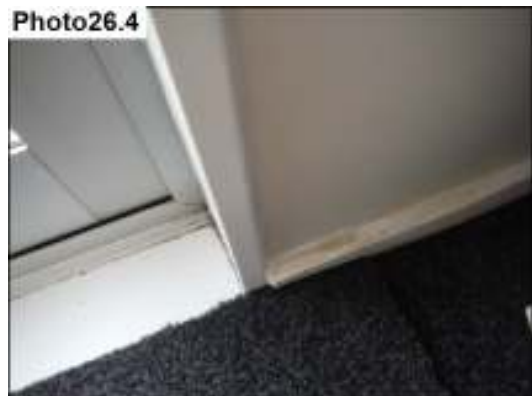
Repairs have been carried out to this
ranch slider

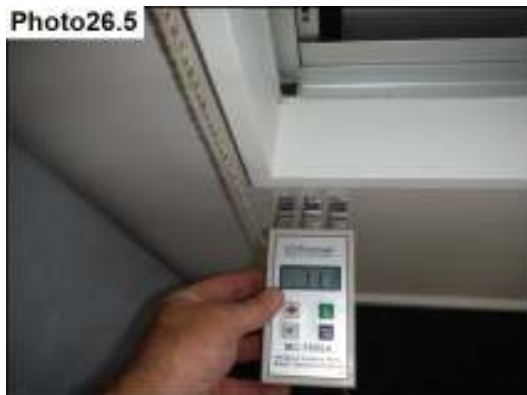
Moisture reading to the window in
the second lounge.
11.1%

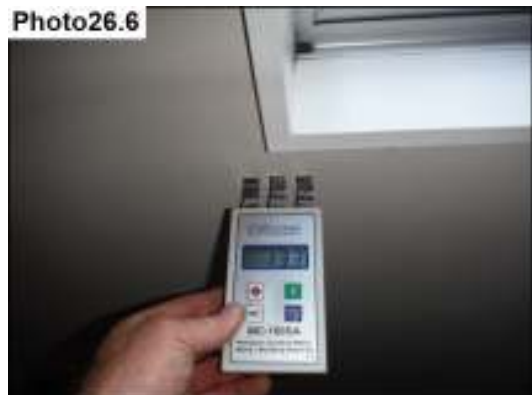
Moisture reading in the office.
13.3%

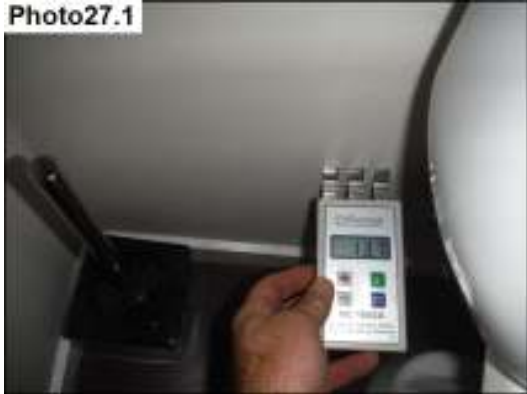
Photo27.1

Moisture reading behind the down stairs toilet

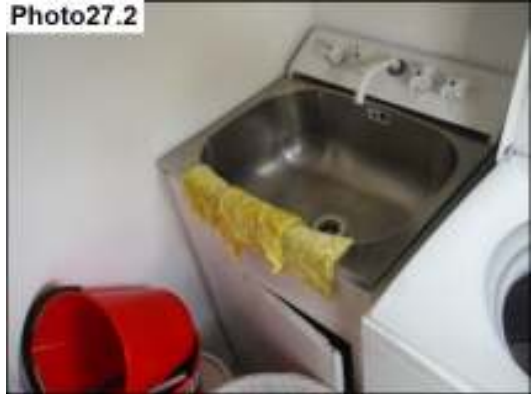
Photo27.2

Supertub needs fixing to the wall.

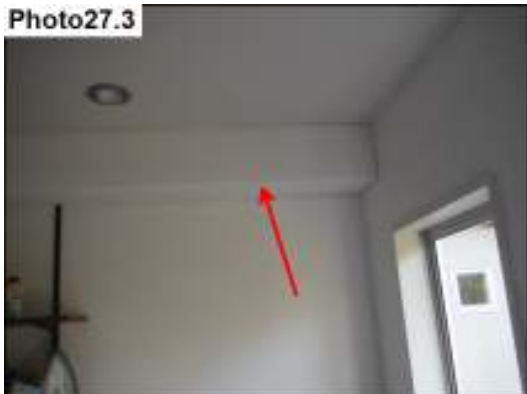
Photo27.3

Duct from the toilet runs across the laundry area.

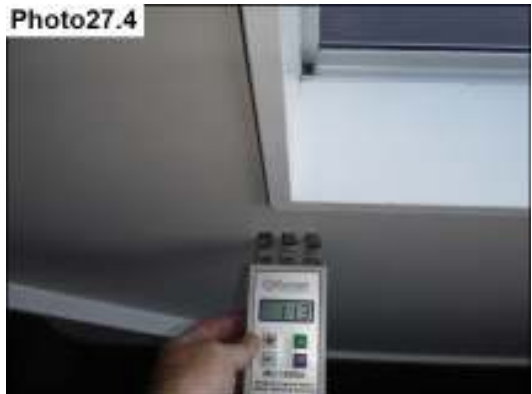
Photo27.4

Moisture reading to the stairwell window.
11.3%

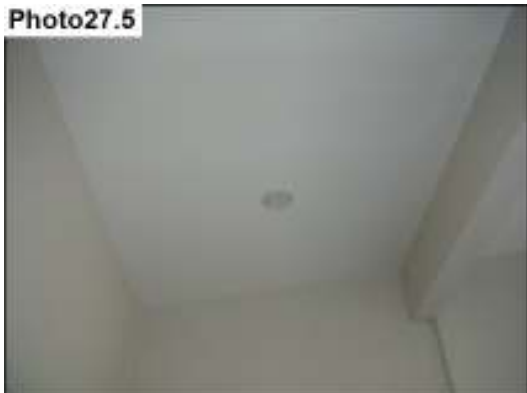
Photo27.5

Smoke alarm need to be reinstalled.

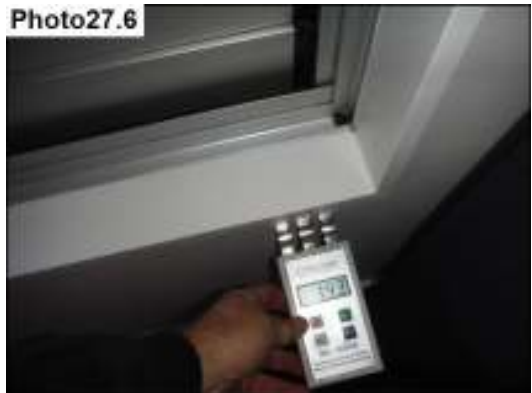
Photo27.6

Moisture reading to bedroom 1
14.3%

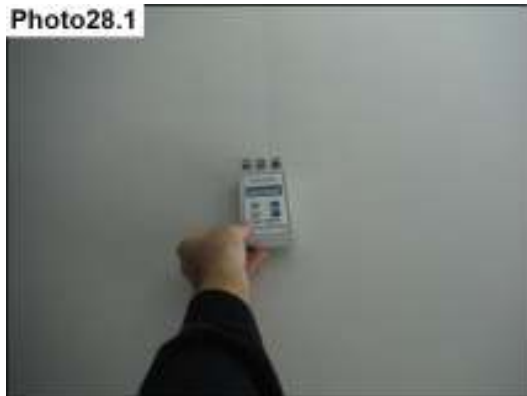
Photo28.1
Moisture reading to the crack in the wall in bedroom 1.
11.5%

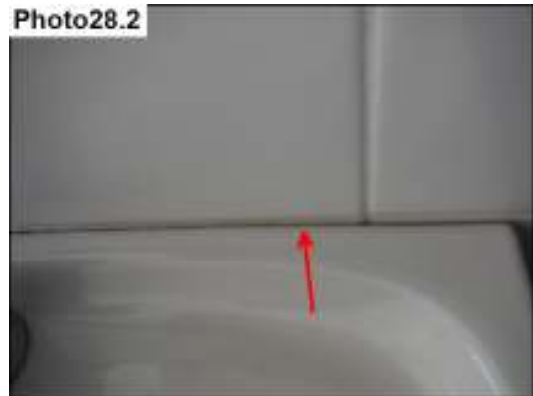
Photo28.2
Basins need to be silicone sealed against the wall.

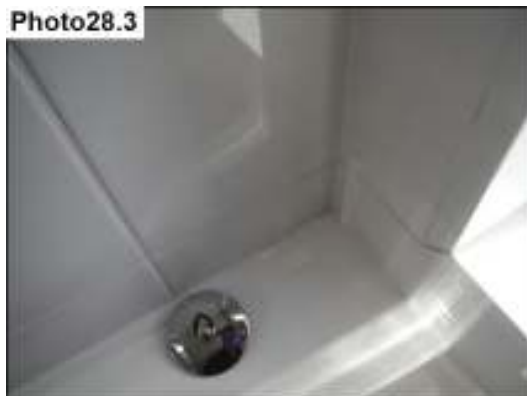
Photo28.3
Silicone sealant around the bath is starting to lift. This will need redoing soon.

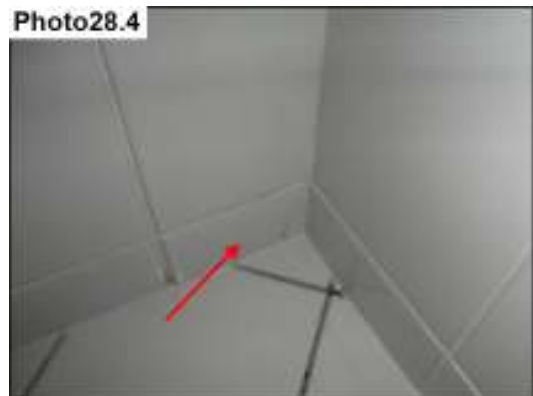
Photo28.4
Cracked tile in the shower. this needs attention.

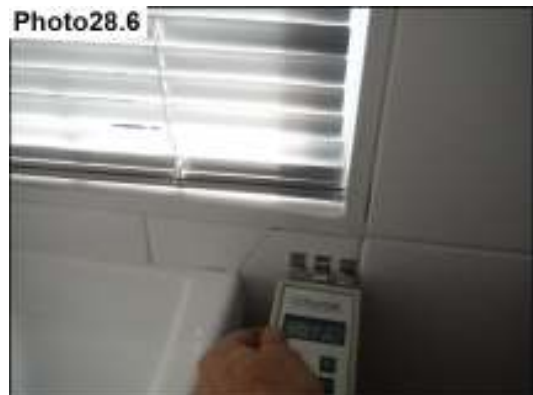
Photo28.6
Moisture reading at the cracked tile to the bath.
12.4%

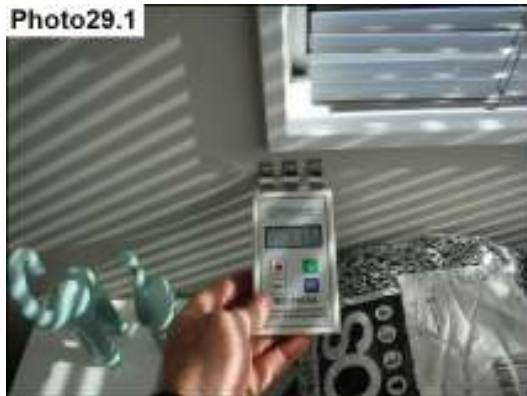
Moisture reading in bedroom 2.
11.6%

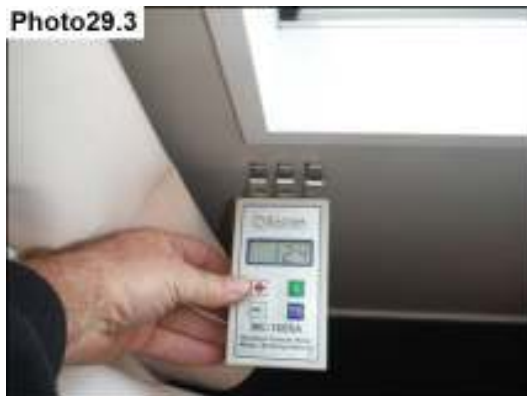
Moisture reading to bedroom 3
12.4%

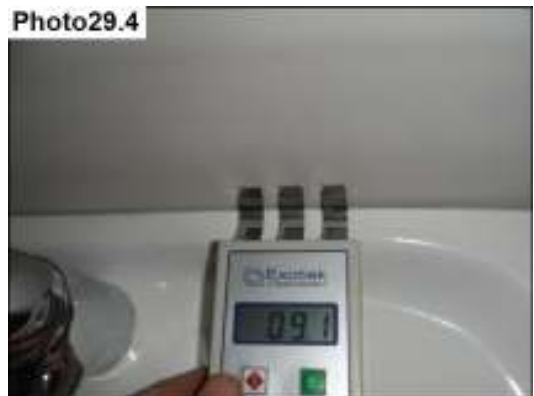
Moisture reading to the ensuite up
stairs basin.
9.1%

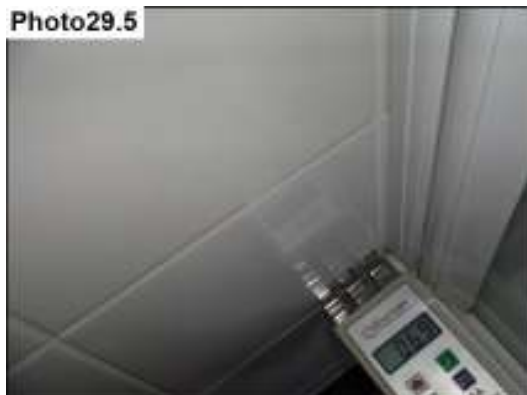
Moisture reading to the ensuite
shower/bath.
6.9%

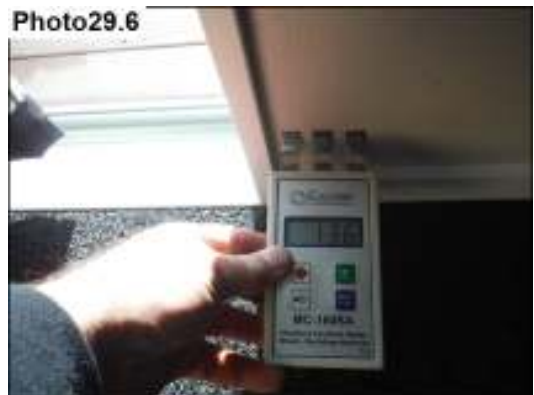
Moisture reading to the master
bedroom.
13.6%

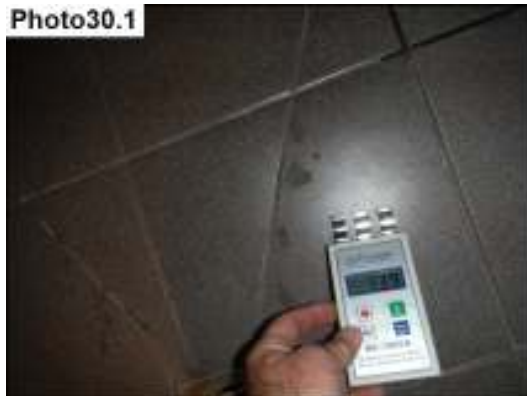
Moisture reading to the master ensuite shower.
13.9%

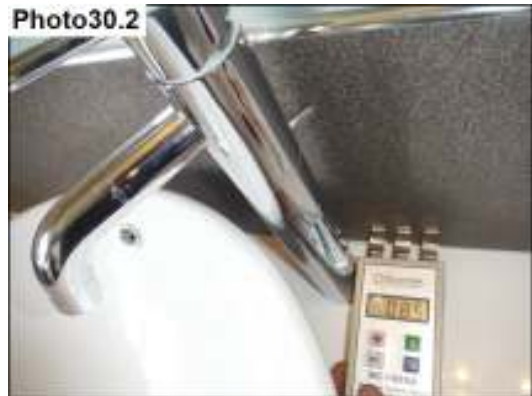
Moisture reading to the master ensuite basins.
8.5%

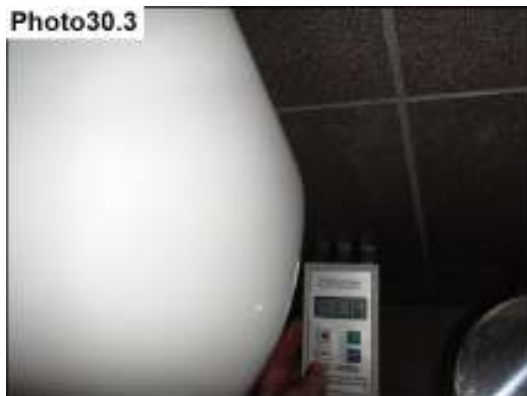
Moisture reading behind the master ensuite toilet.
11.6%

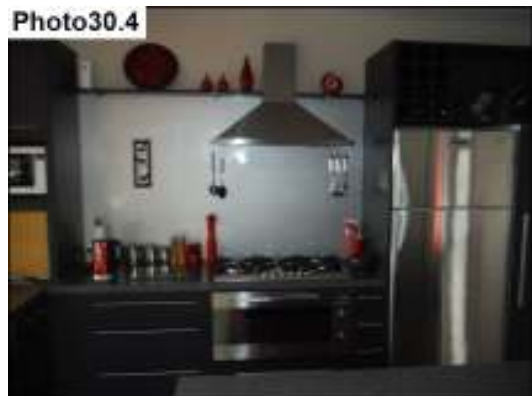
Gas hob with extracting hood and electric wall oven to the kitchen.

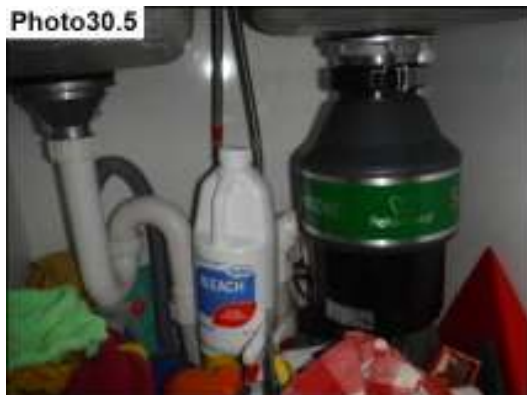
Waste disposer fitted and working.

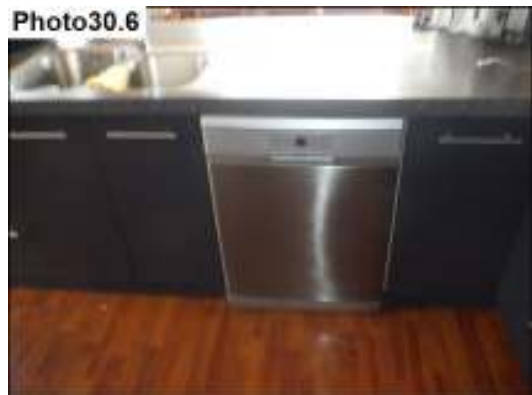
Dish washer fitted to the kitchen area.

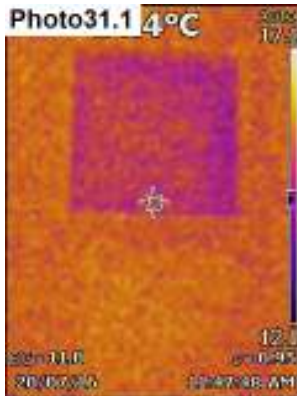
Thermal image of the stairwell window.

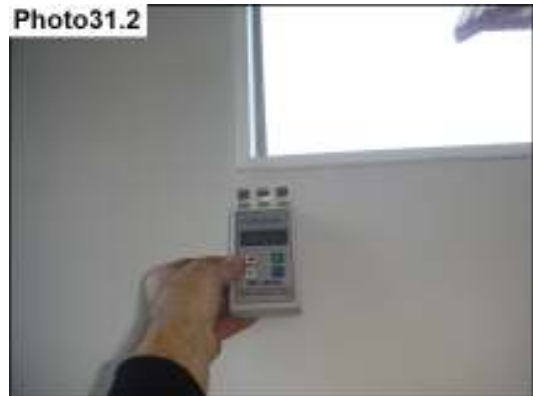
Moisture reading to the stairwell window.
14.3%

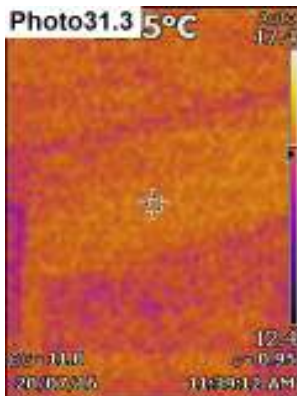
Thermal image of the internal gutter.

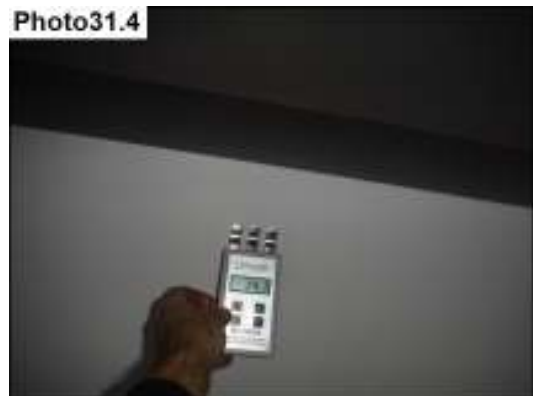
Moisture reading behind the internal gutter.
14.1%

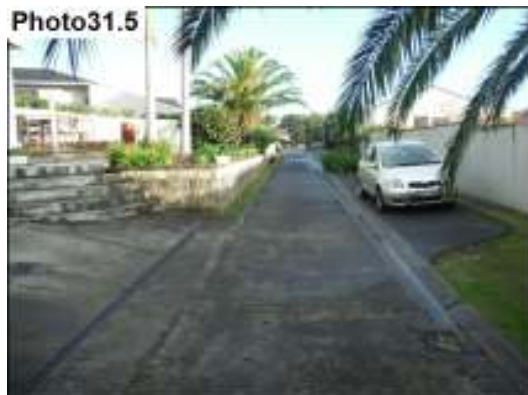
Shared access driveway

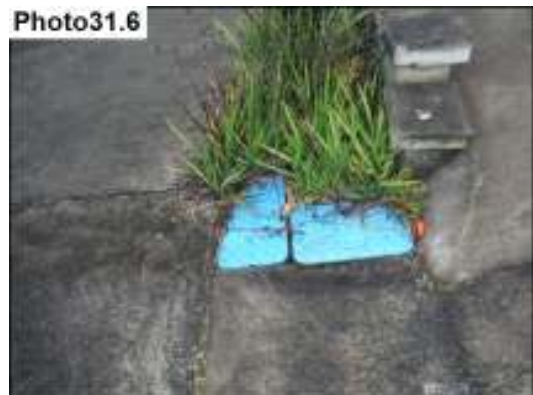
Water toby at the front of the property.
